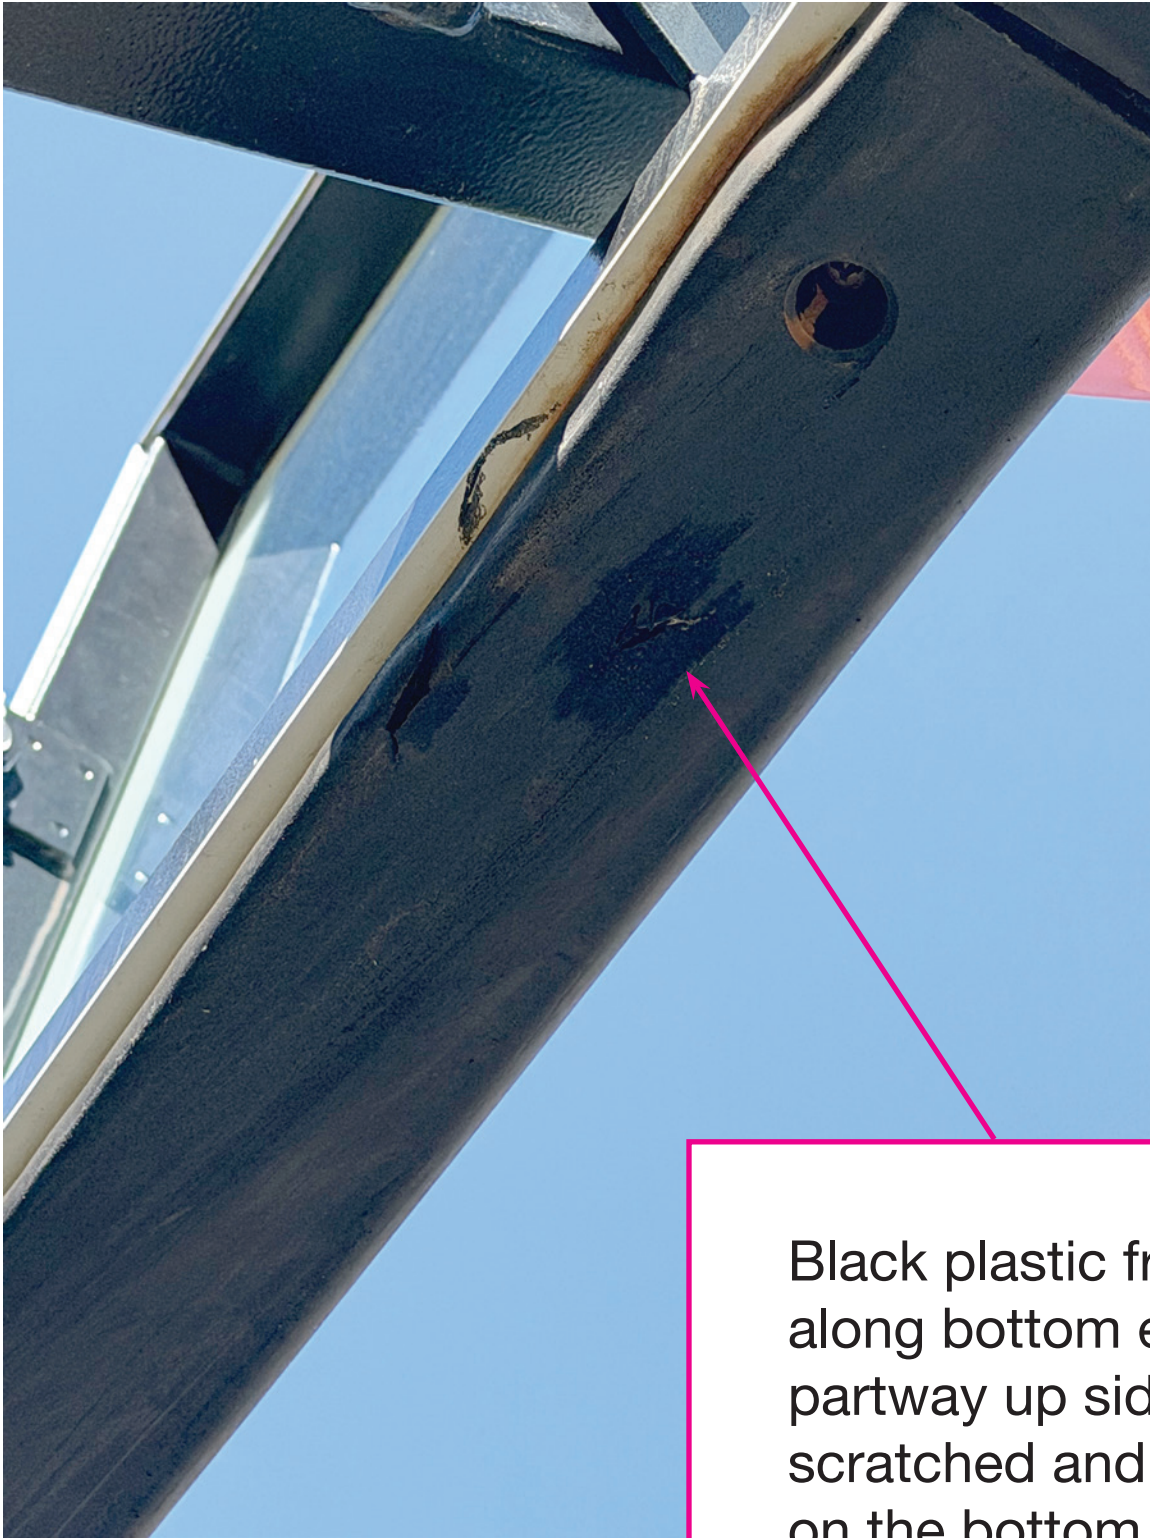
Black plastic frame along bottom edge and partway up sides is scratched and scraped on the bottom where truck roof scraped it; needs replacement.

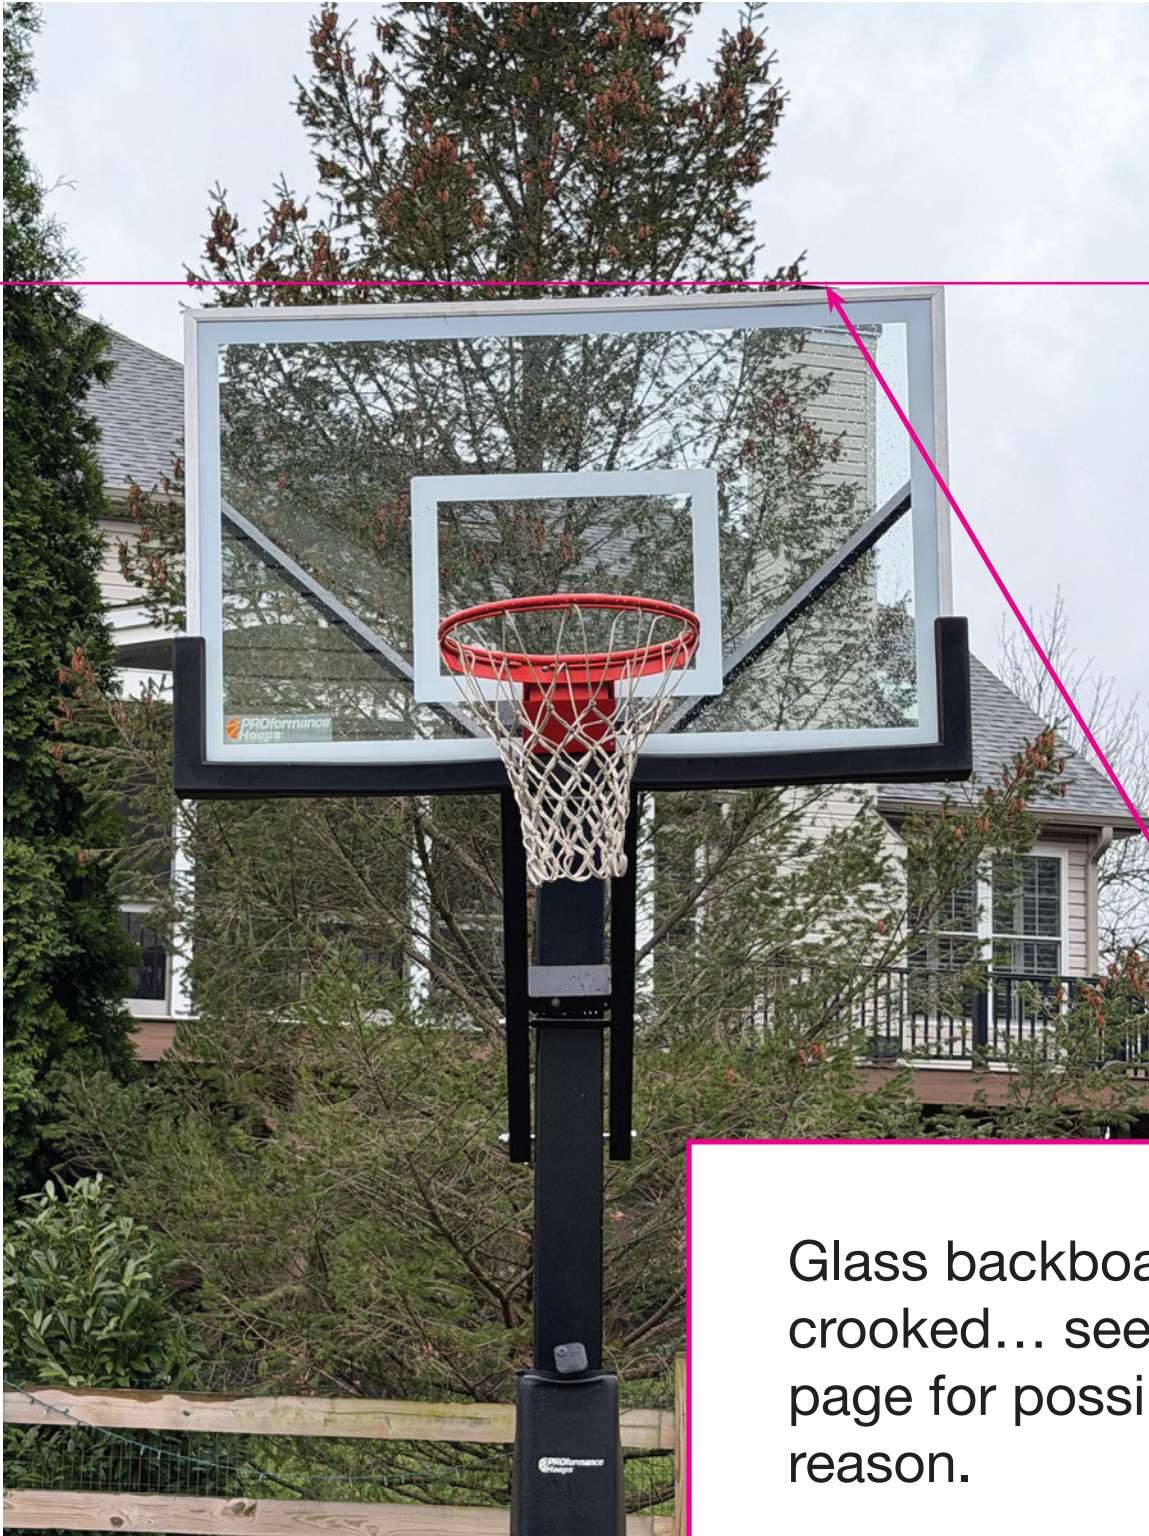
Glass backboard is crooked... see next page for possible reason.

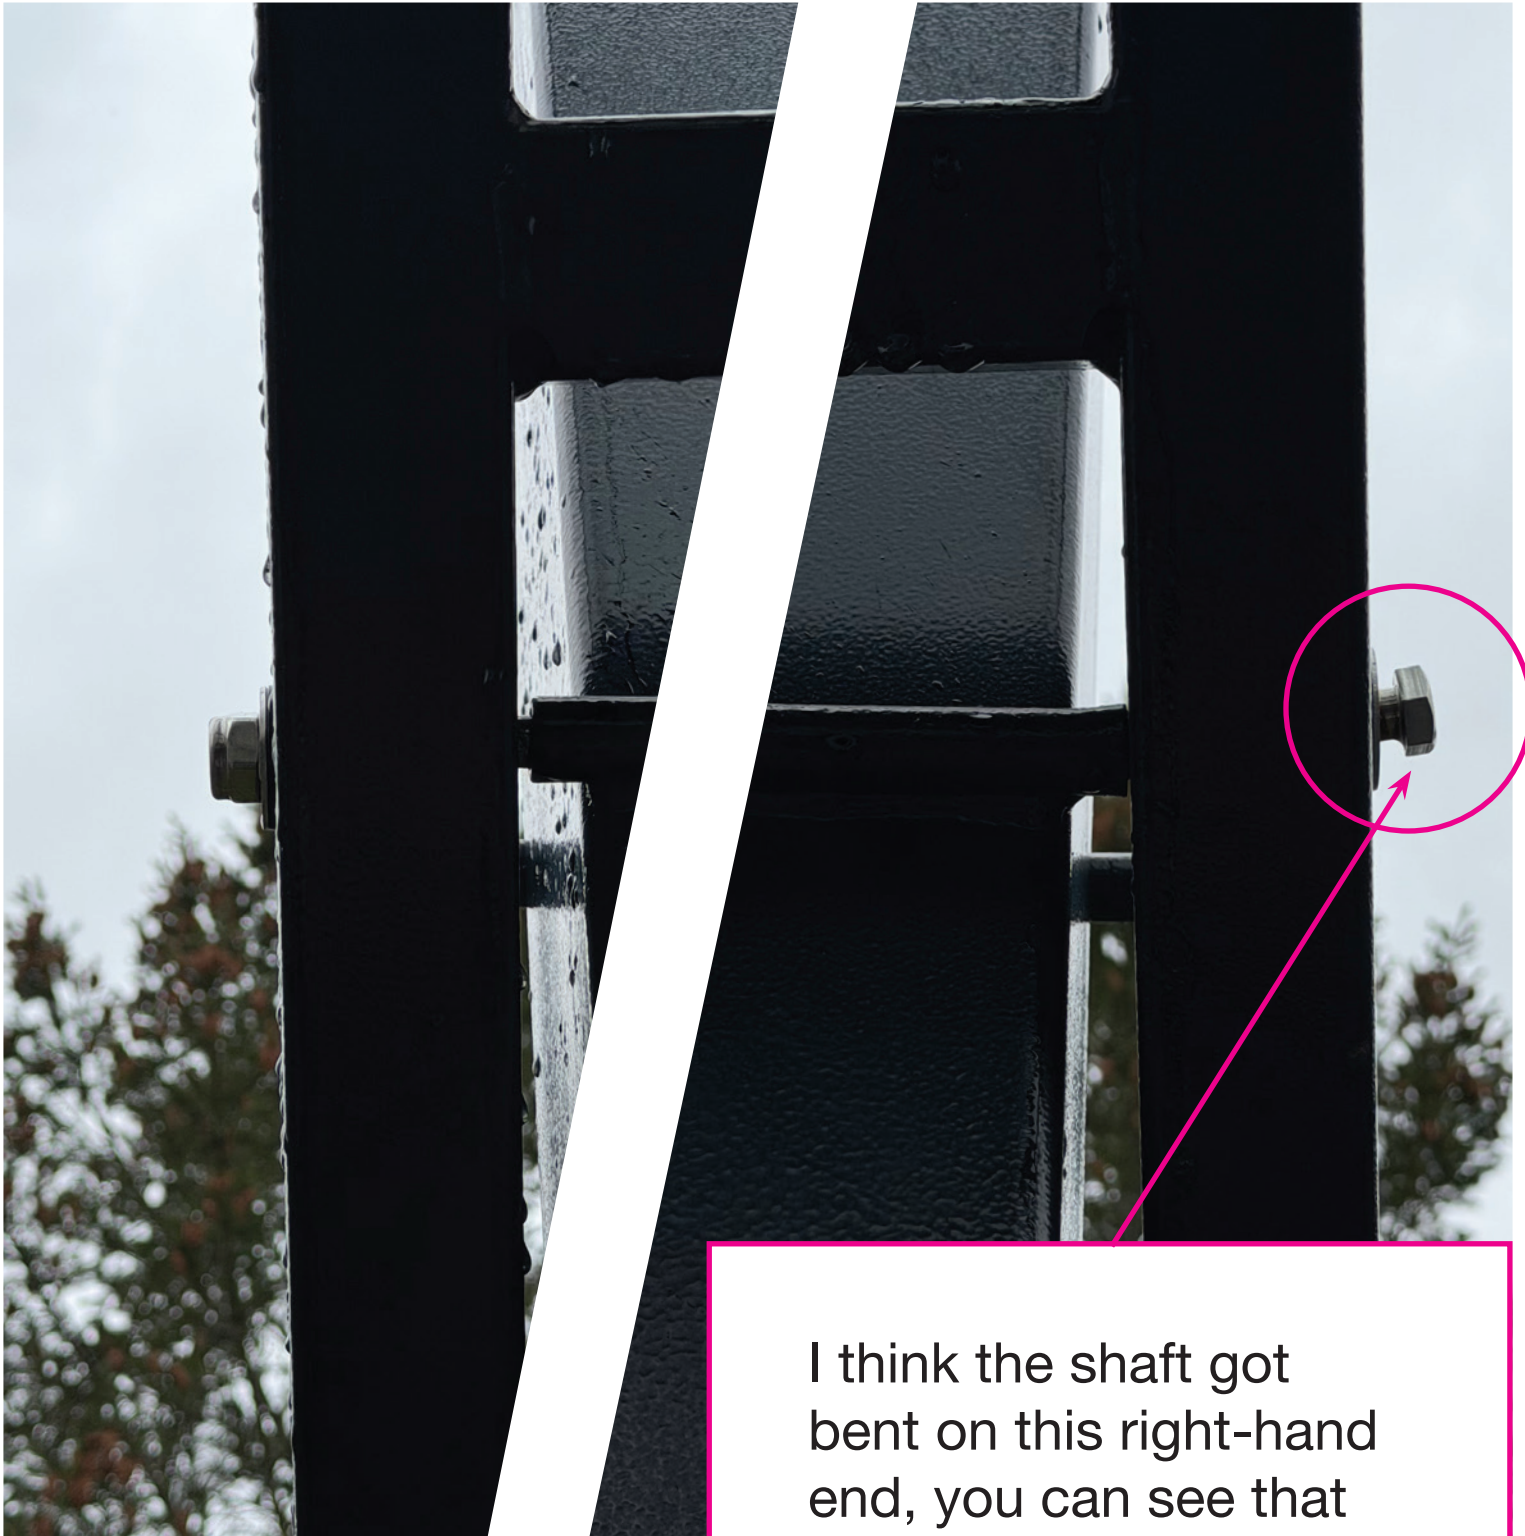
I think the shaft got bent on this right-hand end, you can see that the bolt is pulled-out and crooked compared to the bolt on the left.
